Specification

No. 4037	Make NISSAN		Vehicle SKYLINE		Model GF-ER34		Score 4	
	First Registration 1999 / 7 M	Displacement 2500 cc	Type · Door 2D	Grade 25GT		<div style="border: 1px solid black; border-radius: 50%; padding: 2px; display: inline-block;">2WD</div> · 4WD		Interior Score
Engine Model : RB25DE			Engine : <div style="border: 1px solid black; border-radius: 50%; padding: 2px; display: inline-block;">NA</div> TURBO		Model No. : 09057		Classification No. : 0105

DEFECT REPORT

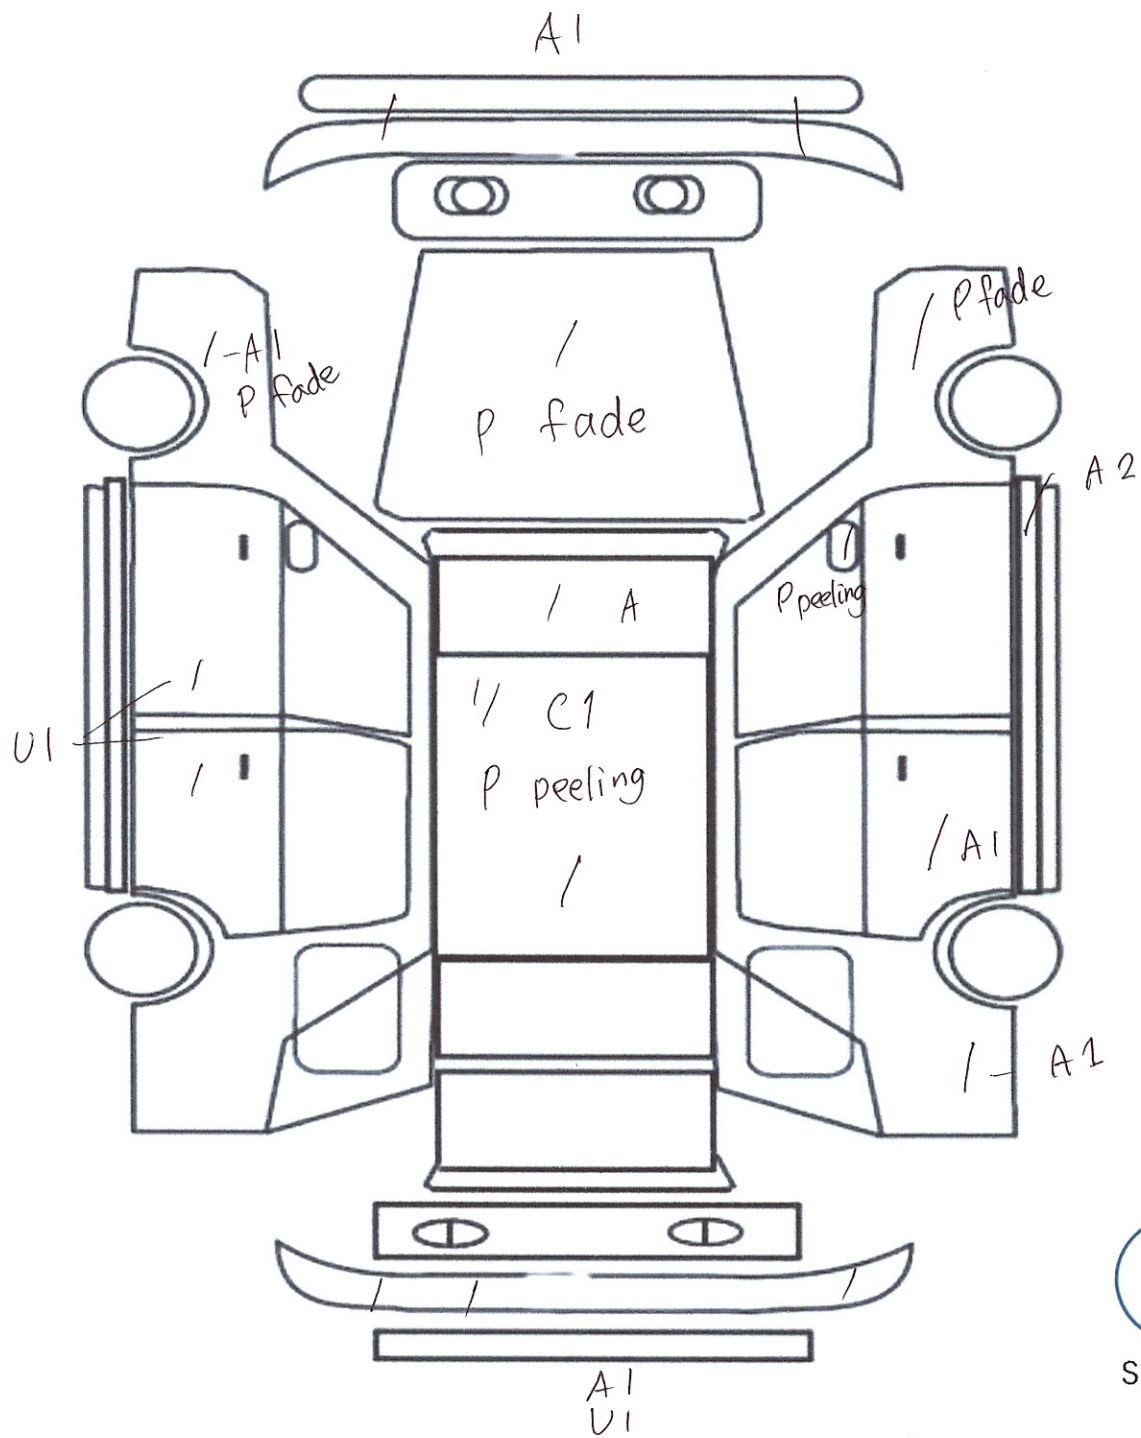
◎ Scar • Dent • Repir Part	◎ Electronic
Front Bumper has scuffs and scratches.	Battery needs replacement.
Has color fade and stains on overall the exterior.	Alternator needs replacement.
Right door mirror has paint peeling.	
Side step has scratches.	
Has scratches on right door.	
Has scuffs on right rear fender.	
Has scuffs and peeling on steering wheel.	
R & L seats has scuffs and worn.	
Has rust and clear coating peeling on roof.	
Has dent on left door.

Side emblems are missing.	Normal car.
Car underbody is rusty.	OEM ALTIA Aero
