# Vehicle Report

No. <b>4180</b>	Make <b>NISSAN</b>		Vehicle <b>SKYLINE</b>		Model <b>E-BNR32</b>		Score <b>R</b>	
	First Registration <b>1994 / 11 M</b>	Displacement <b>2600 cc</b>	Type · Door <b>2D</b>		Grade <b>GT-R</b>	2WD · <b>4WD</b>		Interior Score <b>C</b>
	Engine Model : <b>RB26DETT</b>		Engine : NA / <b>TURBO</b>		Model No. : <b>06134</b>	Classification No. : <b>0015</b>

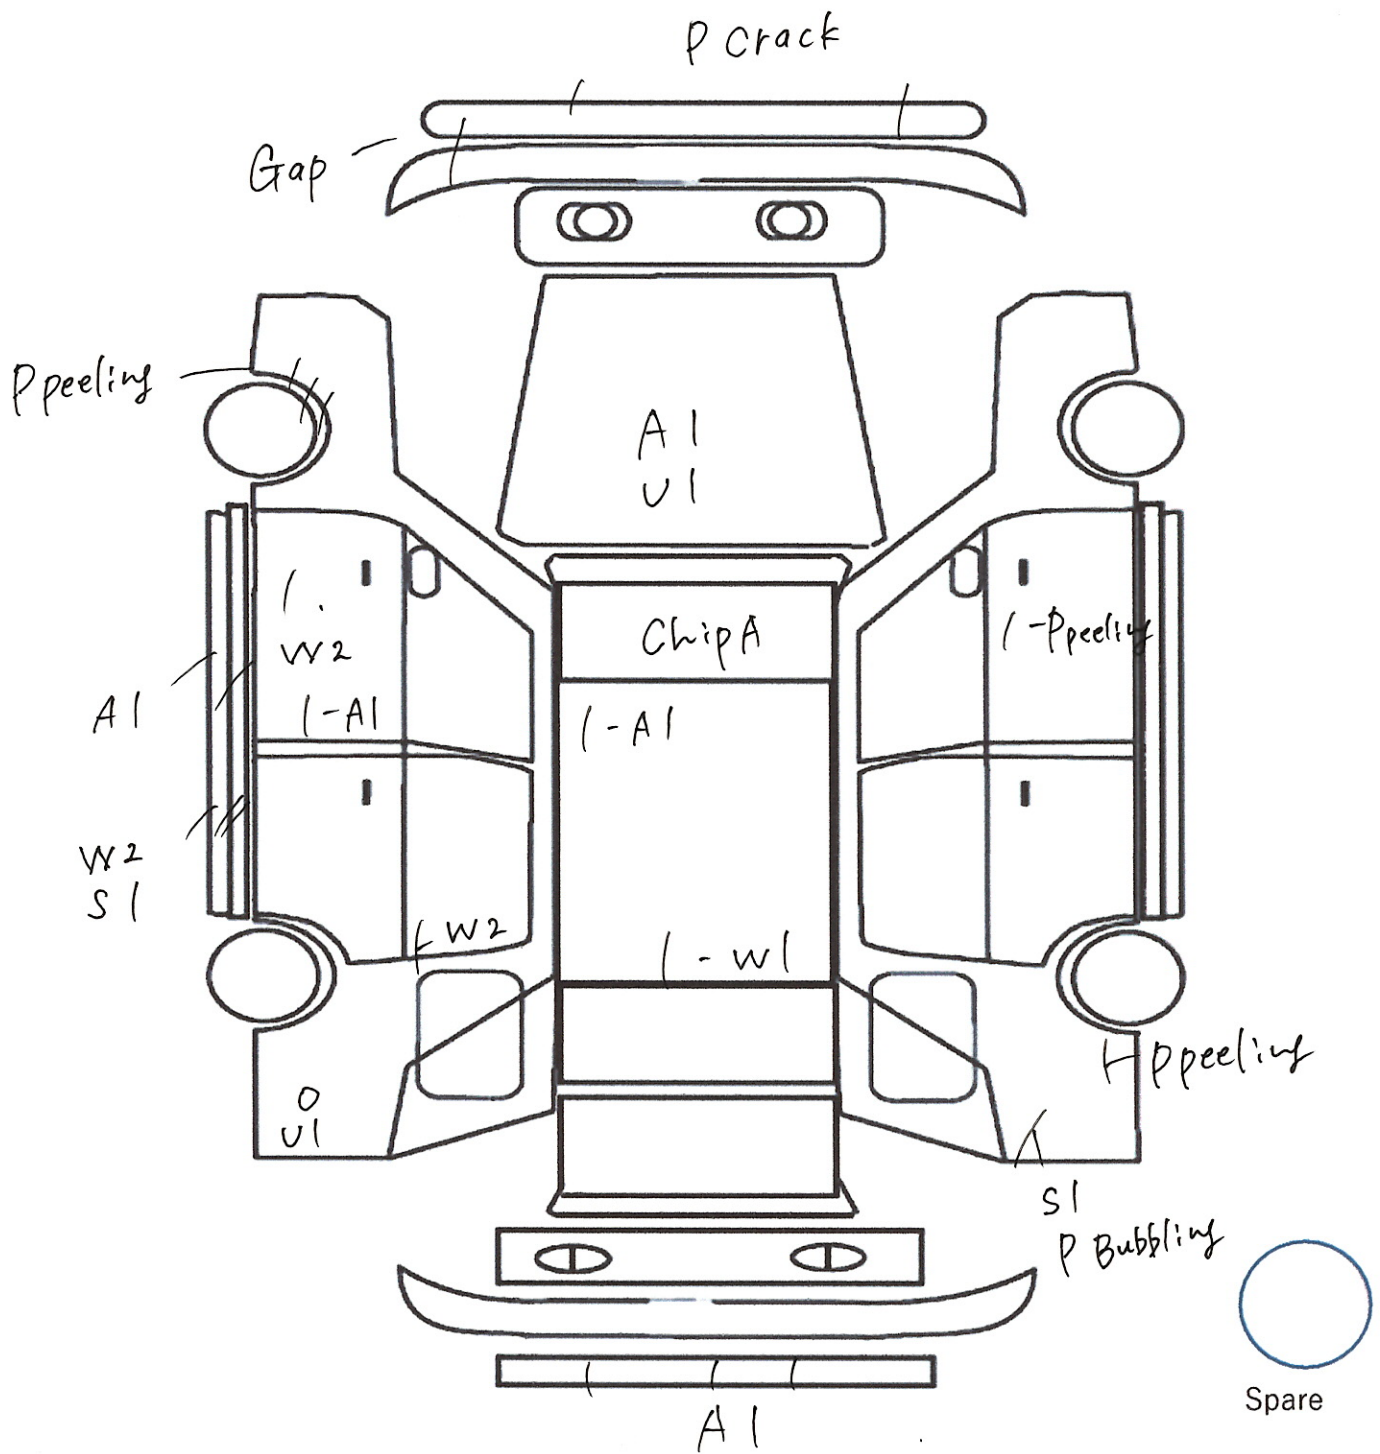
◎Trust Kikaku Inspection Report		
Left door mirror lens isn't in good condition.		
Has hole on console.	Has repair record on rear right side.	
Has drilled screw holes on dash panel.	Has abnormal sound from left front fender.	
Has scuff and stains on seat.		
Audio is installed by modifying dash panel.		
Steering wheel is shaky.		
Right front indicator wasn't lit.		
Car underbody is rusty.		
Has distortion on rear floor.		
Slow in power folding in right door mirror.

☉ Scar • Dent • Repair Part	☉ Electronic
Has hole on console.	Right front indicator wasn't lit.
Has drilled screw holes on dash panel.	Right door mirror power folding need more time.
Has scuffs and stains on seat.	Left door mirror lens is loosen.
Left rear fender was replaced.	
Has repair record on rear right side.	
Has scratches and cracks overall.	
Repaired surface has unevenness.	
Has dent on left rear fender.
