# Vehicle Report

No. <b>4852</b>	Make <b>NISSAN</b>		Vehicle <b>SKYLINE</b>		Model <b>GF-HR34</b>		Score <b>3.5</b>	
	First Registration <b>2001 / 2 M</b>	Displacement <b>2000cc</b>	Type · Door <b>4D</b>	Grade <b>20GT</b>		<input checked="" type="radio"/> 2WD · <input type="radio"/> 4WD		Interior Score <b>C</b>
Engine Model : <b>RB20DE</b>		Engine : <input checked="" type="radio"/> NA / TURBO		Model No. : <b>09056</b>		Classification No. : <b>0001</b>

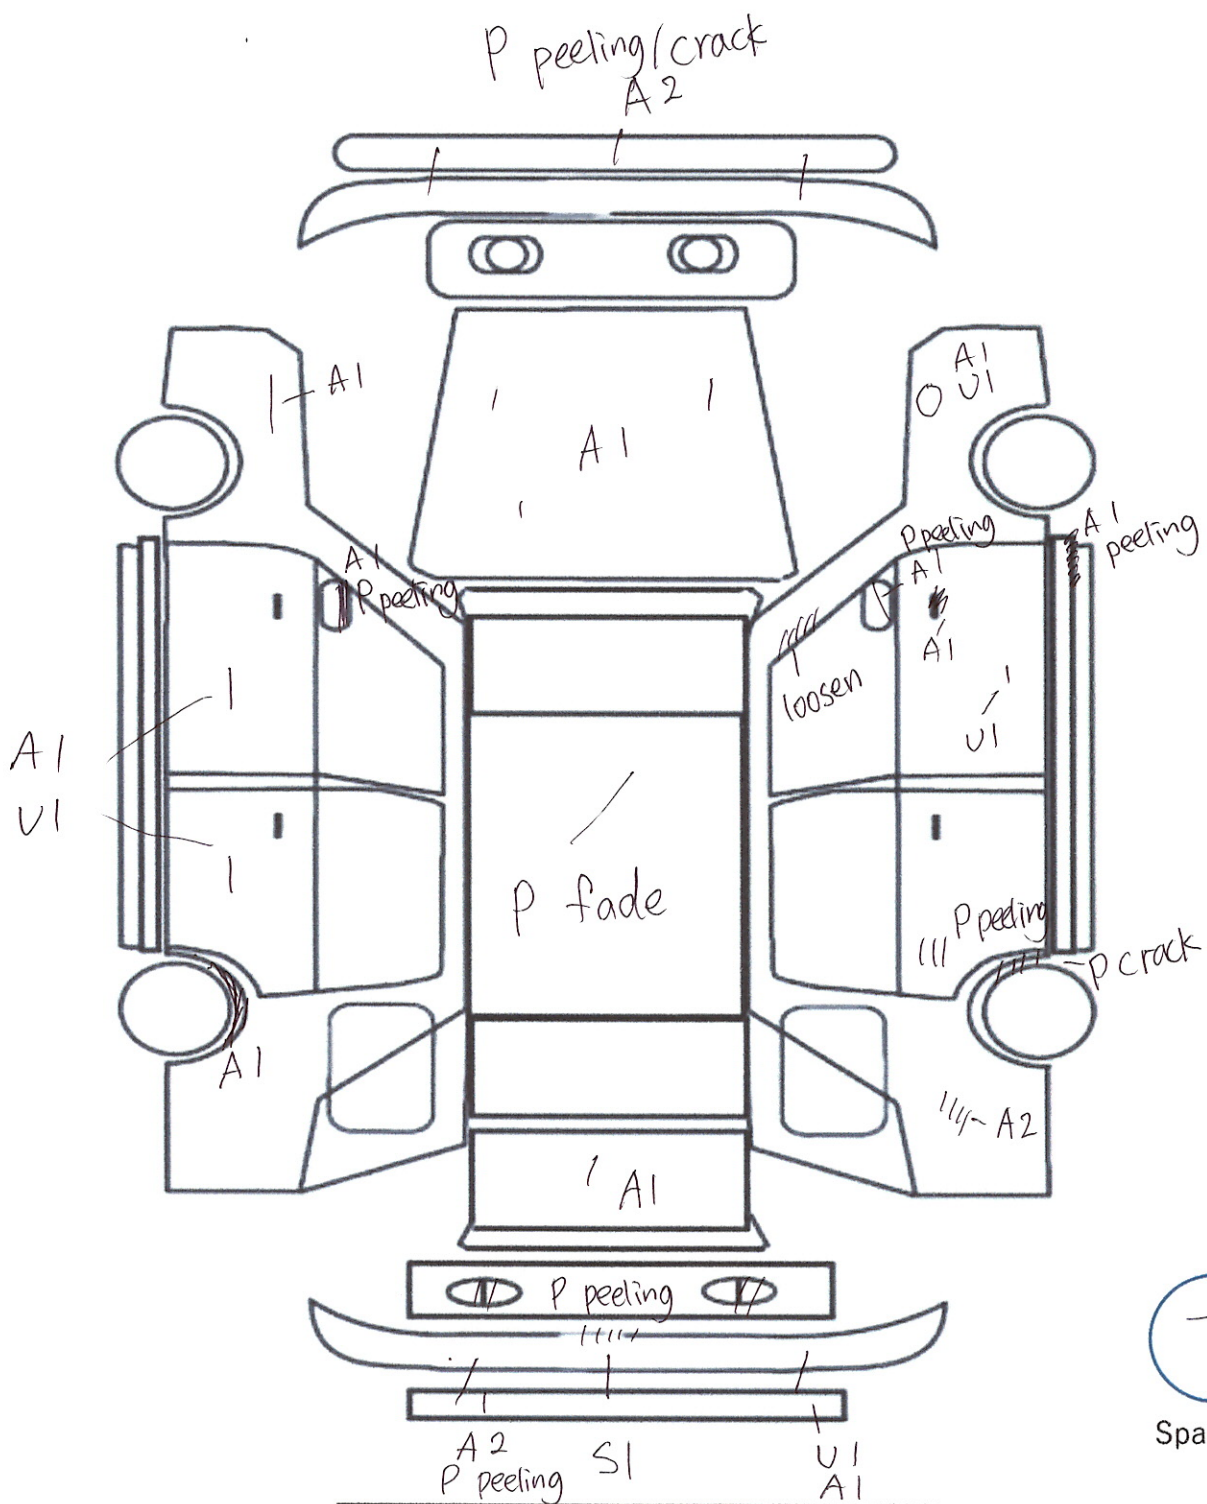
◎ Scar • Dent • Repair Part	◎ Electronic
Has scratches and clear coating peeling on hood.	Right power window is broken.
Has discolor, cracks, marks of repair on front bumper.	Audio is not working right.
Interior has scratches and stains.	
Has scratches and small dents on R&L doors.	
Has scuffs, worn and stains on R&L seats.	
All 4 wheels has scratches, stains and paint bubbling	
caused by rust.	
Has scratches on R&L door mirrors.	
Around the high mount lamp is rusty.	
Engine has abnormal sound.	
Right rear fender has cracks on paint.

OTHER	RECOMMEND POINT
Has scratches and paint peeling on rear bumper.	
Left rear fender has scratches.	
Has scuffs and scratches on side step.	
Car underbody is rusty and has corrosion.
