Vehicle Report

No. 4932	Make NISSAN		Vehicle SKYLINE		Model E-BNR32		Score R	
	First Registration 1992/7M	Displacement 2600cc	Type · Door 2D		Grade GT-R	2WD · 4WD	Interior Score	C
	Engine Model : RB26DETT		Engine : NA / TURBO		Model No. : 06134	Classification No. : 0016

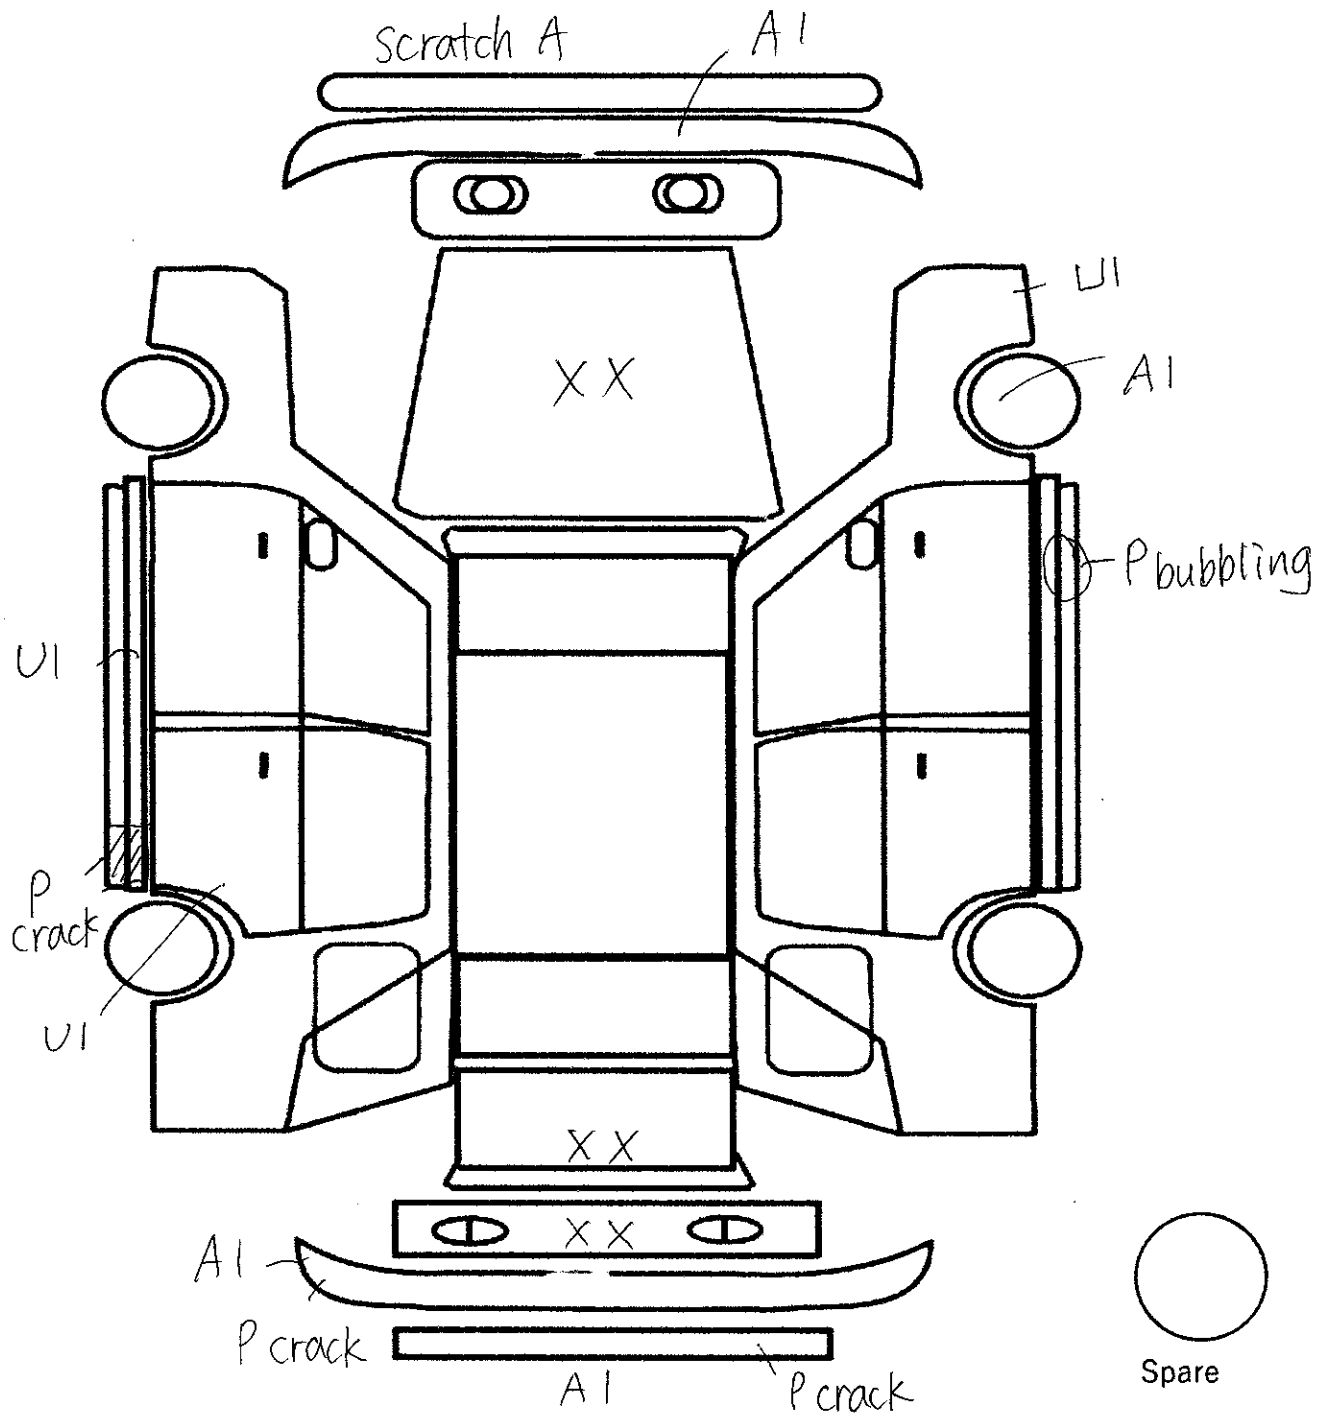
◎ Scar • Dent • Repir Part	◎ Electronic
• Front bumper has scratches underneath.	• Clock doesn't display time.
• Has dent on right side front fender.	• A/C is not working.
• Has paint bubbling on right side side step.	• Has abnormal sound from air mix actuator.
• Has scratches and paint cracks on rear bumper.	
• Trunk and lip spoiler has paint cracks.	
• Has dent on left side rear fender.	
• Has cracks on side step end on left side.
