Vehicle Report

No. 4997	Make NISSAN	Vehicle SKYLINE	Model GF-ENR34		Score 2	
	First Registration 2000/3M	Displacement 2500cc	Type · Door 2D	Grade 25GT FOUR	2WD 4WD	Interior Score C
Engine Model : RB25DE		Engine : NA / TURBO		Model No. : 09058	Classification No. : 0013

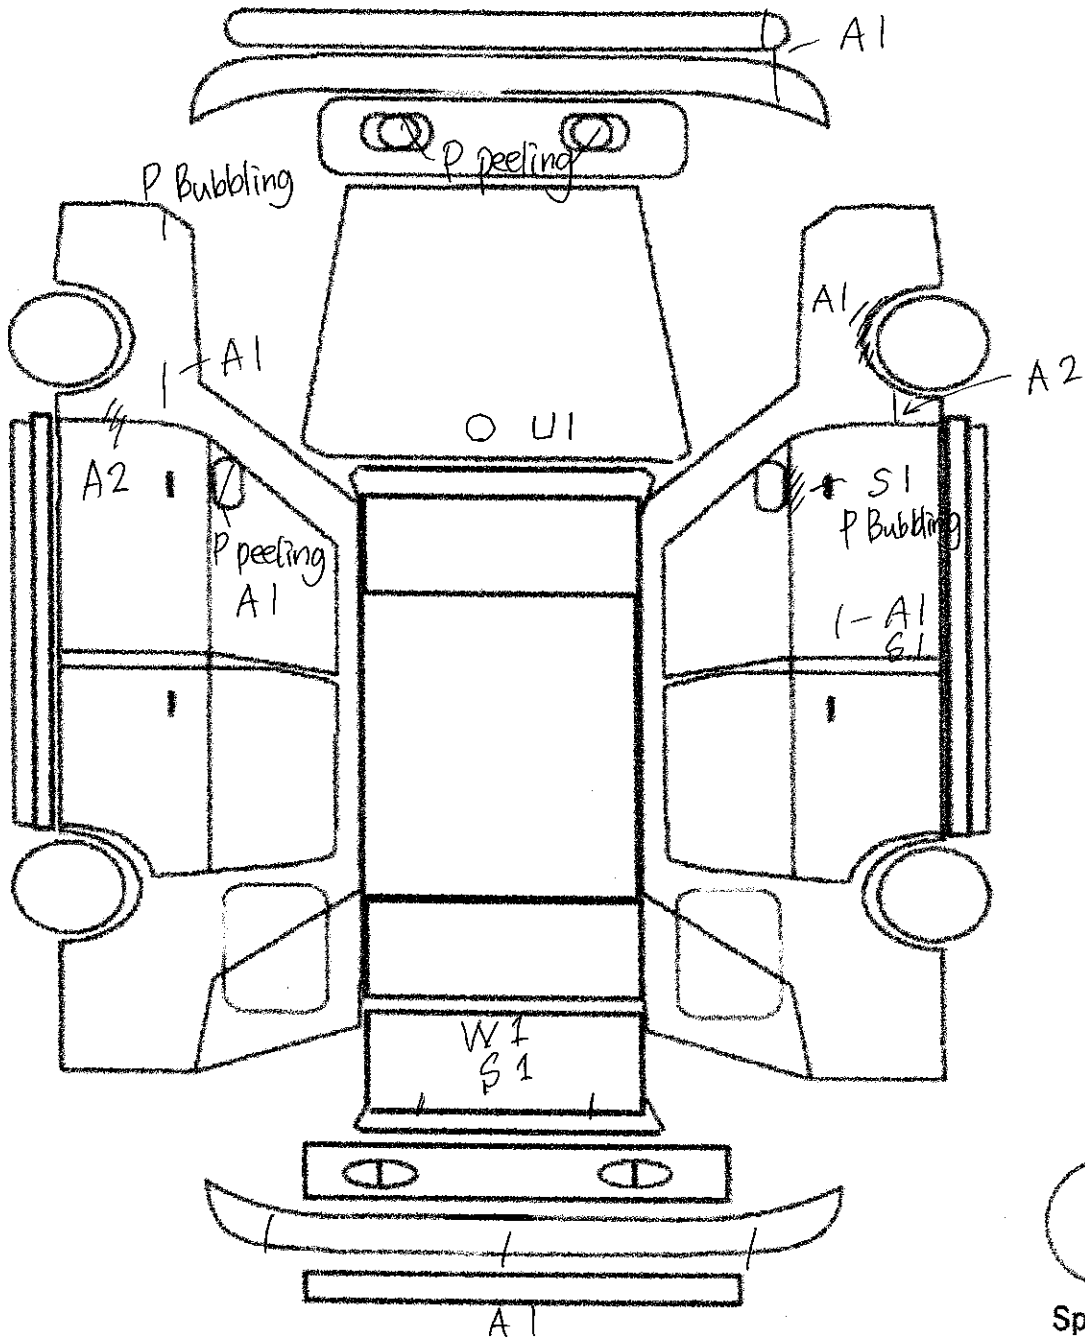
◎ Trust Kikaku Inspection Report		
· Very rusty underneath and has corrosions.		
· Has rust on strut tower.		
· Rear piece tip has dent on muffler.		
· Has dent on jack points.		
· Has tear, scuffs and worn on seat.		
· Interior has stains.		
· Has repair marks on floor.		
· Body color is faded.		
· Better to check actual car.

☉ Scar • Dent • Repair Part	☉ Electronic
• Has scratches on front bumper.	
• Has dent on hood.	
• Has repair marks on floor.	
• Has paint bubbling on front left fender.	
• Has scratches on both right & left fenders.	
• Has rust and paint bubbling around right door mirror.	
• Has scratches and paint peeling on left door mirror.	
• Has rust and repair marks on mounting part of rear wing.	
• Has scratches on rear bumper.	
• Has dent on muffler rear piece side.
