# Vehicle Report

No. <b>5004</b>	Make <b>NISSAN</b>		Vehicle <b>SKYLINE</b>		Model <b>GF-ER34</b>		Score <b>3</b>	
	First Registration <b>2000/3M</b>	Displacement <b>2500cc</b>	Type · Door <b>2D</b>		Grade <b>25 GT TURBO</b>	2WD · 4WD	Interior Score	<b>C</b>
Engine Model : <b>RB25DET</b>		Engine : NA <b>TURBO</b>		Model No. : <b>09057</b>		Classification No. : <b>0161</b>

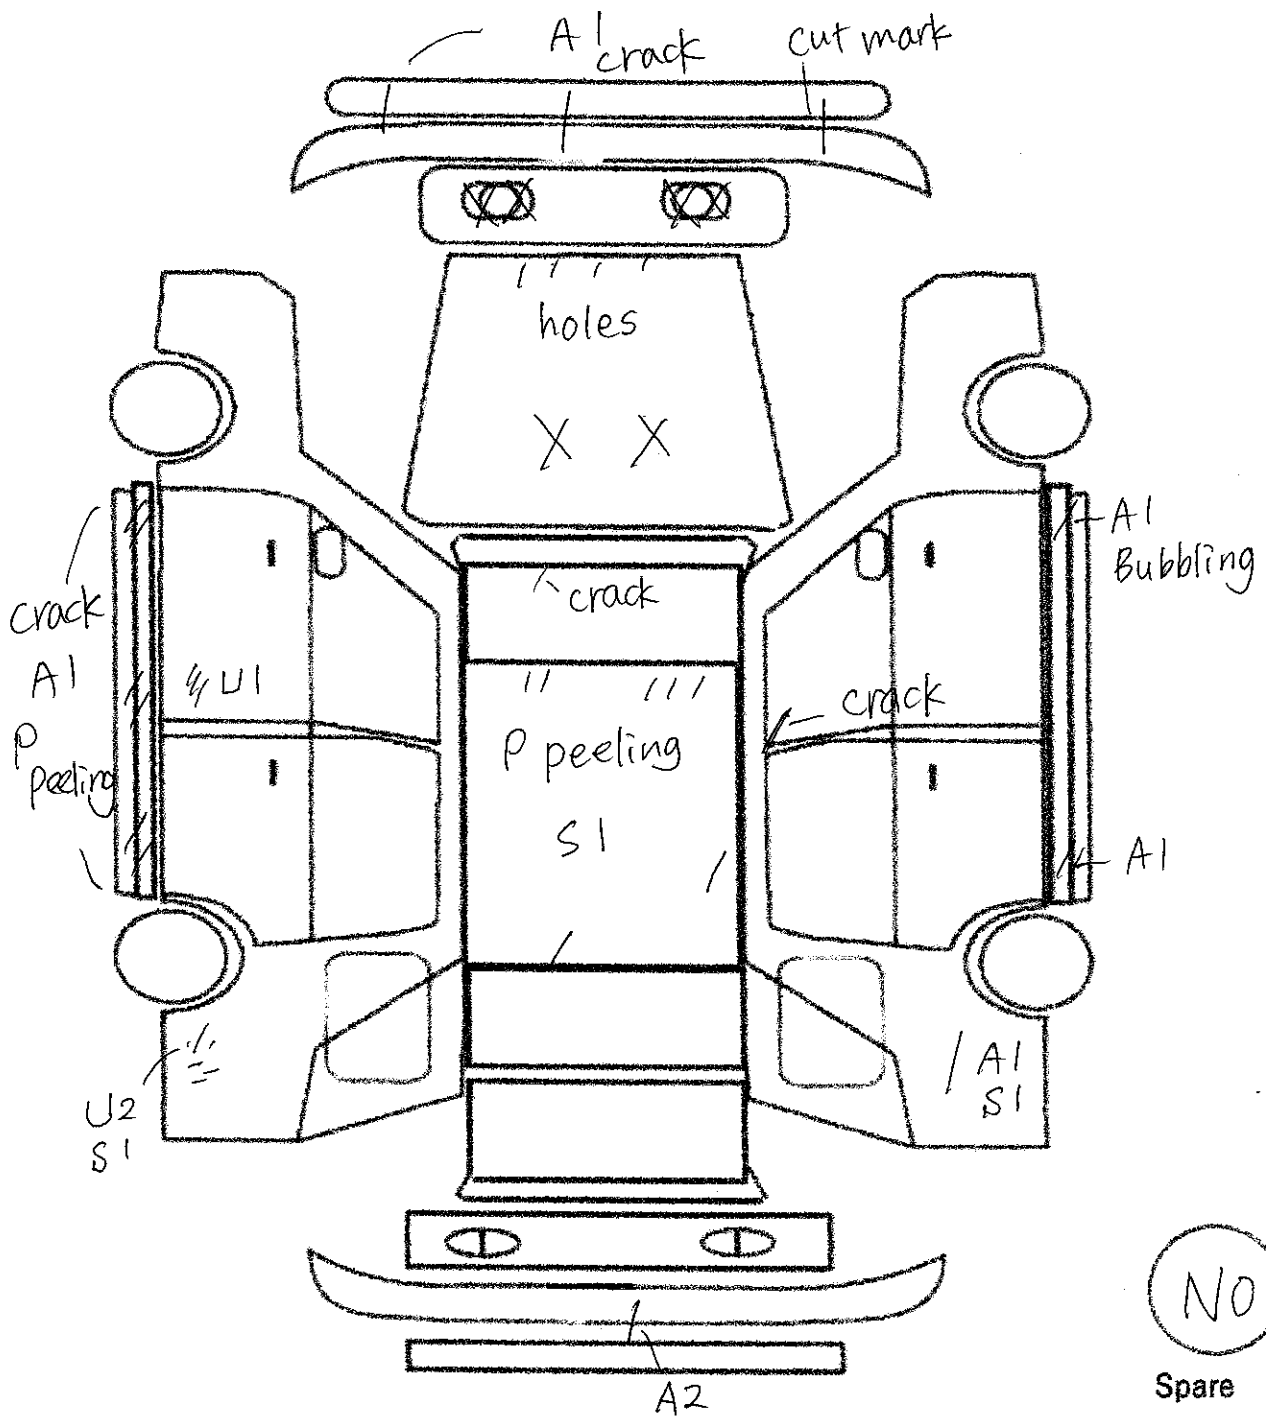
5004

☉ Scar • Dent • Repair Part	☉ Electronic
• Front bumper has crack and scratches.	• Door mirror power folding and adjustment are not
• Has scratches and cracks on side step.	working fine.
• Has paint peeling on roof.	• Side indicators are not lit on.
• Has scratches on rear bumper.	• Some headlight bulbs are not lit on.
• Right rear fender has scratches.	• Meter check lamp is lit on.
	• BRITZ tachometer is not working.
	• AUTOGAUGE Voltmeter and Oil Temp meter gauge
	are not working.

• Has crack on front windshield.	• Rare 2 door coupe!
• Power steering has abnormal sound.	• OEM 5 speed transmission!
• Hood pin doesn't work well.	• Popular WORK Meister Wheels!
Has scuffs, stains and tear on seat.	• Has lots of additional meters and custom parts like
• Muffler is hung and rusty.	coilovers on this car!
• Has exhaust gas leak around catalyzer.	• How about having this car as base car?
• Has rust underneath.	
• Has cut and stains in interior.	
• Has dent on front member.	
• Has cut marks on front right instrument panel.
