## Vehicle Report

No. <b>5103</b>	Make <b>MAZDA</b>	Vehicle <b>RX-7</b>	Model <b>E-FD3S</b>	Type/Door <b>2D</b>	Score <b>3</b>
	First Registration <b>1998 / 2</b> <sub>M</sub>	Displacement <b>RE</b> <sub>cc</sub>	Grade <b>TYPE RZ</b>	<b>2WD</b>	
					Interior Score <b>C</b>

### ✓ Trust Kikaku Inspection Report

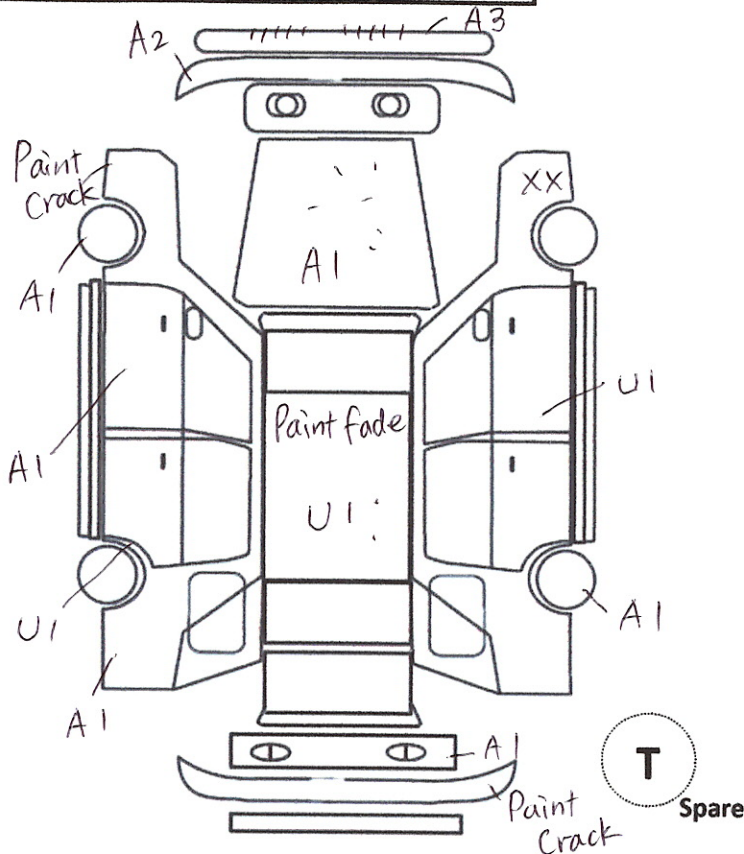
- Has scratches over all.
- AirBag Alert Lamp is ON.
- Has tear on driver seat.
- Has distortion on left baffle.
- Left front fender liner is missing.
- Engine Compression Result  
Front Side: 0.71/0.73/0.74  
Rear Side: 0.73/0.75/0.71

• Has scratches and paint cracks on front bumper.	• Nothing in paticular.
• Has scratches on hood.	
• Has scratches on front lip spoiler.	
• Has scratches on roof.	
• Has scratches and paint cracks on rear bumper.	
• Has scratches on passenger's seat side door.	
• Driver's seat side door handle is not fit well.	
• Has gutter marks and rust on Aluminum wheel.	
• Has dent on driver's seat side door.

• Has yellowing on indicator.	• Rare! 1998 model FD3S RX-7 Type RZ!
• Has cracks on right side A/C vent.	• RZ OEM RECARO bucket seat & BBS Wheels!
• Console box has cut on leather.	• Engine, exterior and suspension are fully normal!
• Driver's seat side door handle is not fit well, and it is shaky.	• Suspension is stable! No worn!
• Has coolant fluid leakage.	• Gear shifts smoothly and no abnormal sound!
• Has engine oil leakage.	• ETC, CARROZERIA HDD Navi are installed!
	• NARDI Classic Wood Steering Wheel!
	• MAZDA Speed Down Pipe & Muffler!
