トラスト企画 Trust Kikaker

Vehicle Report

No.	Make	Vehicle	Model		Score
2415	NISSAN	SKYLINE	GF-HR34		R
	First Registration	Displacement / Type・Door	Grade	2WD・4WD	Interior Score: C
	2000/9 M	2000 cc / 4D	20GT		
Engine Model : RB20DE	Engine : NA / TURBO		Model No. :		Classification No. :

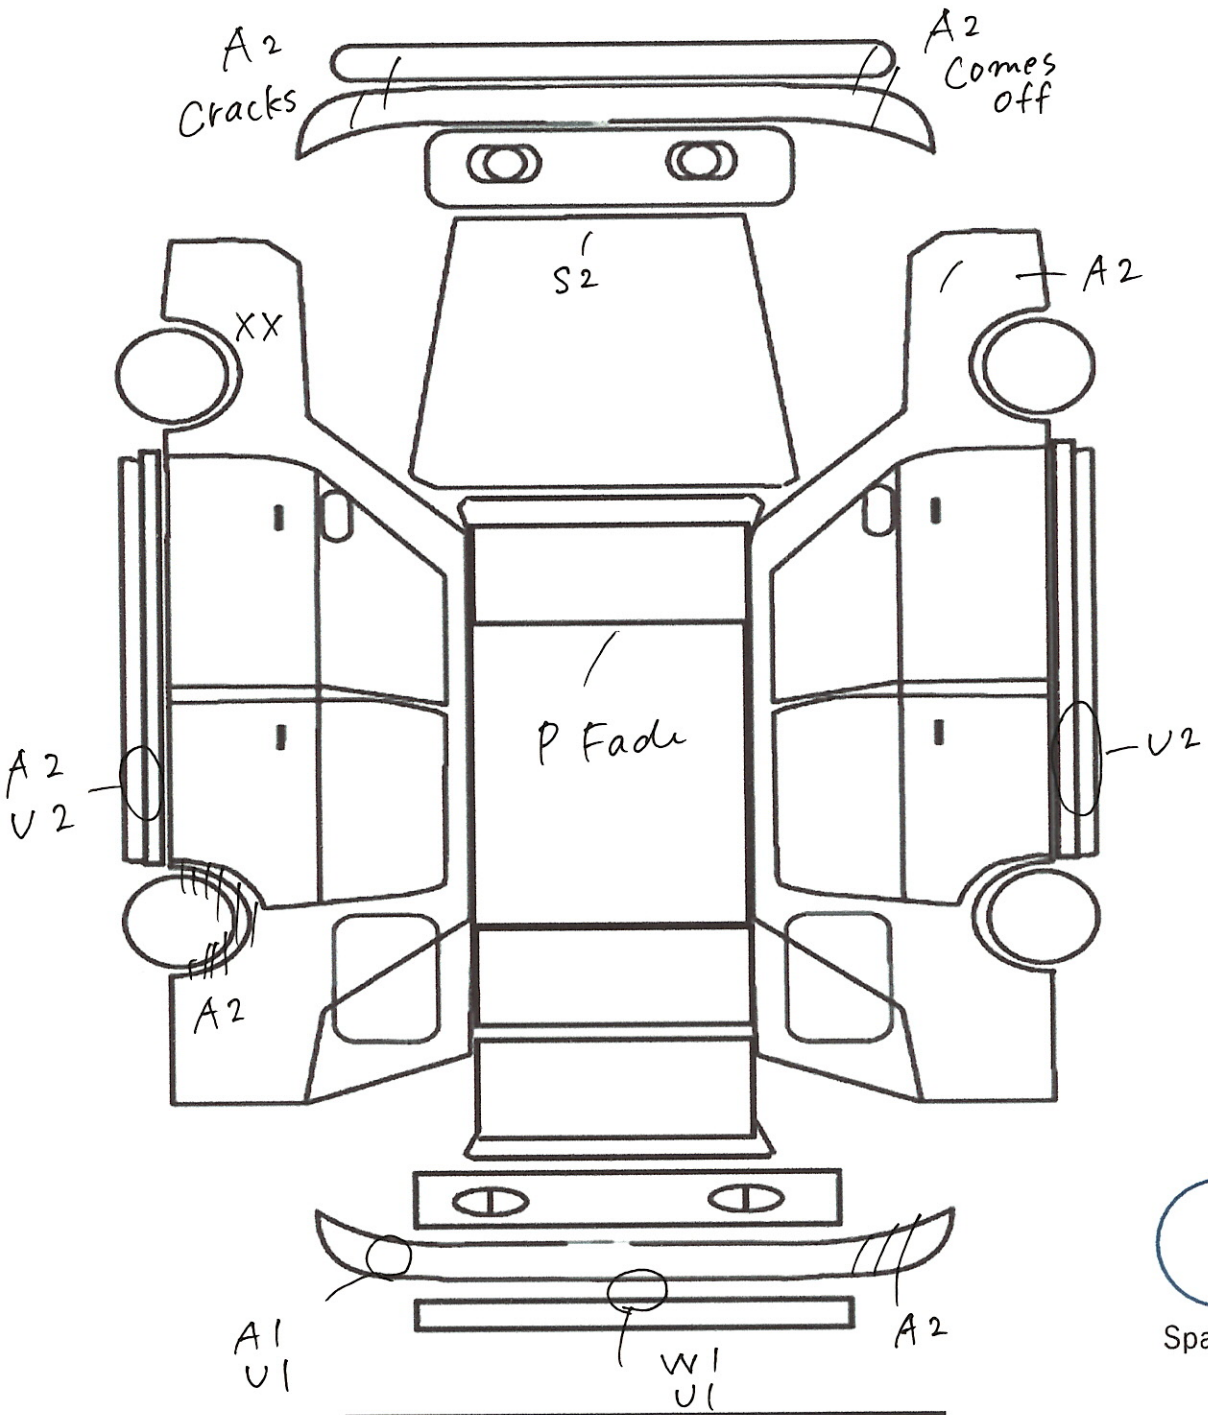
2415

◎ Scar・Dent・Repir Part	◎ Electronic
Has dent and cracks on front bumper	
and it doesn't fit right.	
Muffler is bent.	
Left front inner panel and core support has repair marks.	
Right front fender has scars.	
Left rear fender has scuffs.	
Rear bumper has scuffs, cracks and dent.	
Car underneath is rusty.	
Has dent and scuffs on left side step.	
Has dent on right side step.
