Vehicle Report

DEFECT REPORT

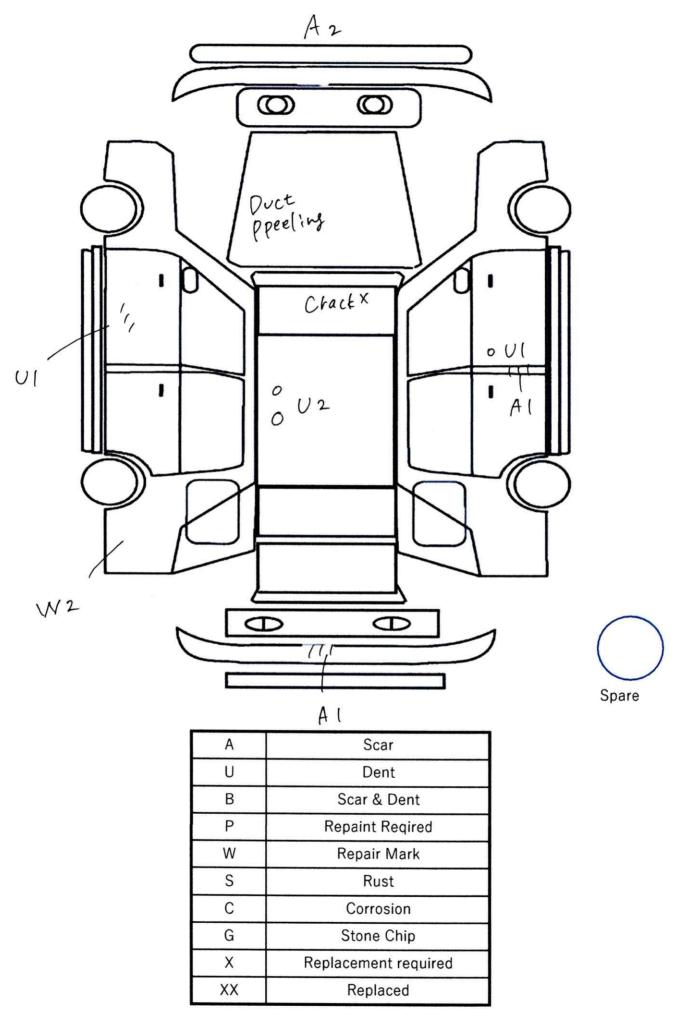
No.		Make		Vehicle)	Model			Sc	ore
		MITSUBI	SHI	LA	NCER		GF-CP9A			?
43	80	First Registration	Displacer	nent	Type · Door			2WD		1
		2000 / 4 M	200	0 сс	4D		Evolution 6 akinen Edition	4WD	Interior Score	С
Engine M	odel:	4G63	Engine:	NA /	(URBO)	Model No.:	09027	Classification No. :)76
Inspection	n Valid (S	haken) :	×		Shift Type	5F	OEM S R Parts Leather Seat	©EM AW	P S Navi	P W Airbag
Mileage			0 Km Mile	>[*]	AC	AAC	Passenger	5		
Dody	Base Color	Color Change		Code:	Туре	ļ	D !!		<u>' </u>	Seater
Color	WHITE	Gasoline		r Color :	Maintenance	\ \ \ \ \ \ \ \ \ \ \ \ \ \ \ \ \ \ \	Recycling	4	_	
Fuel	Diesel F			K/RED	Book	A •(N)]	1,63	<u>) </u>	JPY
© Specifo	cation									
Additional	aftermark	ket meter : Water te	emp /							
Oil temp /	Oil pressu	ure / Boost gauge								
Aftermark	et 260km	speedometer								
HPI air cl	eaner									
TEIN coilo	ver									
⊚Trust Ki	ikaku Insp	ecton Report								
Has distor	rtion on let	ft front instrument	panel.

Car underbody is rusty.										
Modified o	odometer (car.								
Paint is no	ot grossy.									
Seat has s	scuffs.									
Has scuffs	s and peel	ing on steering whe	eel.							
Liner has	peeled off	area.								
Has scrato	ches and c	dent overall.

○ Electronic
Headlight has yellowing.	There is no problem.
Exteriors are discolored.	
Doors has dent on both sides.	
Has huge dent on roof.	
Melting around muffler tip.	
Has small scratches and marks of touch ups.

OTHER	RECOMMEND POINT				
Driver's seat has scuffs and worn.	Rare Tommy Makinen Edition.				
Liner on driver's seat side has peeled off area.	Nothing wrong with engine.				
	Good for restore base.
